# **An Brief History & Analysis of the Cambridge Leper Chapel**

**Cortney Cain Gjesfjeld**  
**June 2020**

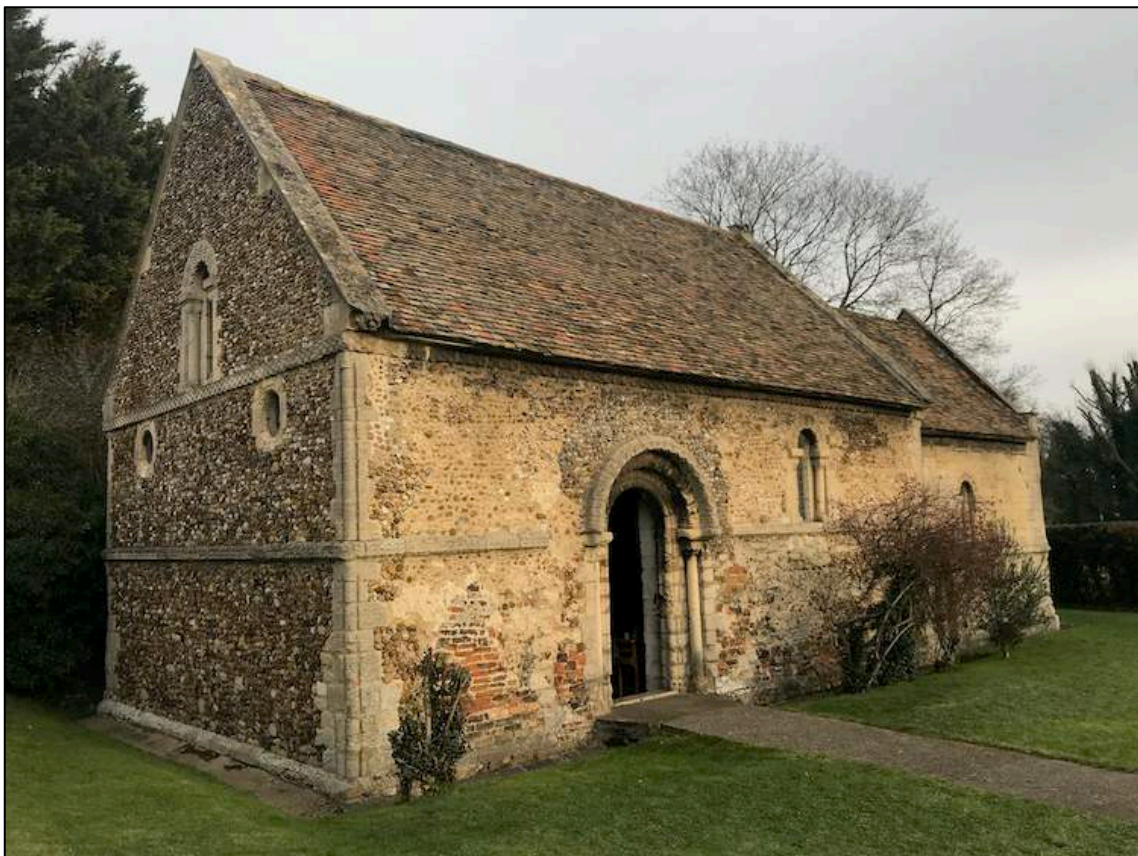
Figure 1: Photograph of the Cambridge Leper Chapel looking northeast showing existing conditions (Gjesfjeld 2019).

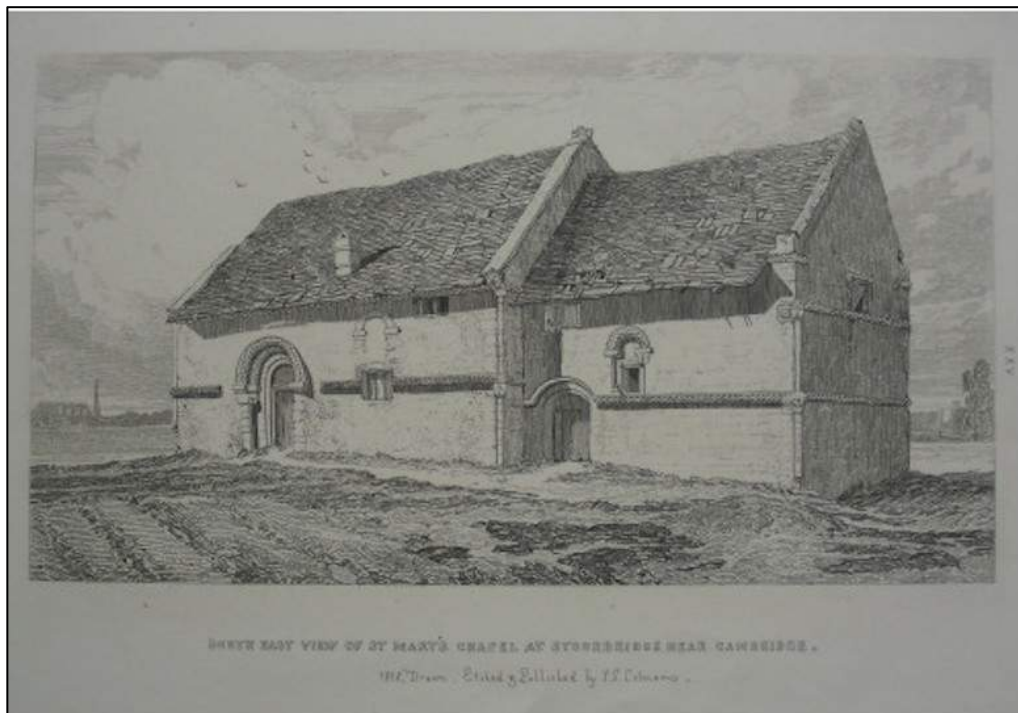
Figure 10: Etching of the Cambridge Leper Chapel looking northwest. The window location and shapes appear consistent with those identified in the 1725 drawing; however, this image shows the introduction of a chimney in the nave. The roof appears to be in poor condition and the east wall of the chancel shows a small window above the string course. Note the open character of the landscape beyond the chapel and the uneven topography in the foreground with paths leading to both doors, 1818 (Cotman 1819).

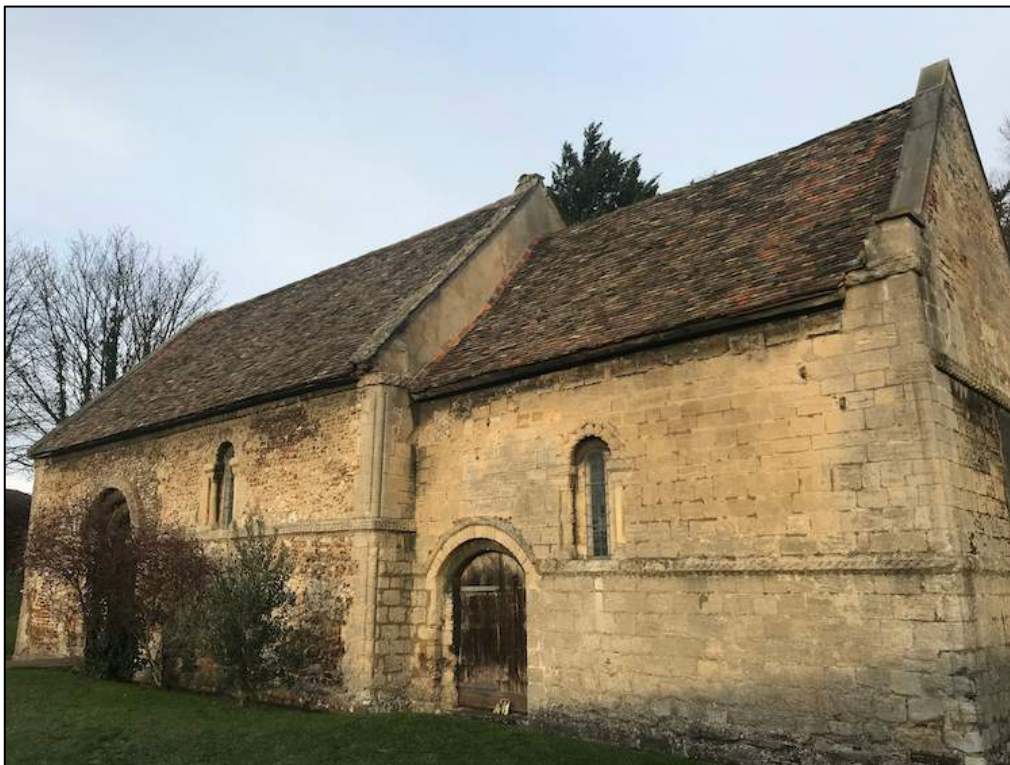
Figure 11: Photo of the Cambridge Leper Chapel looking northwest showing the primary façade of the building (Gjesfjeld 2019).

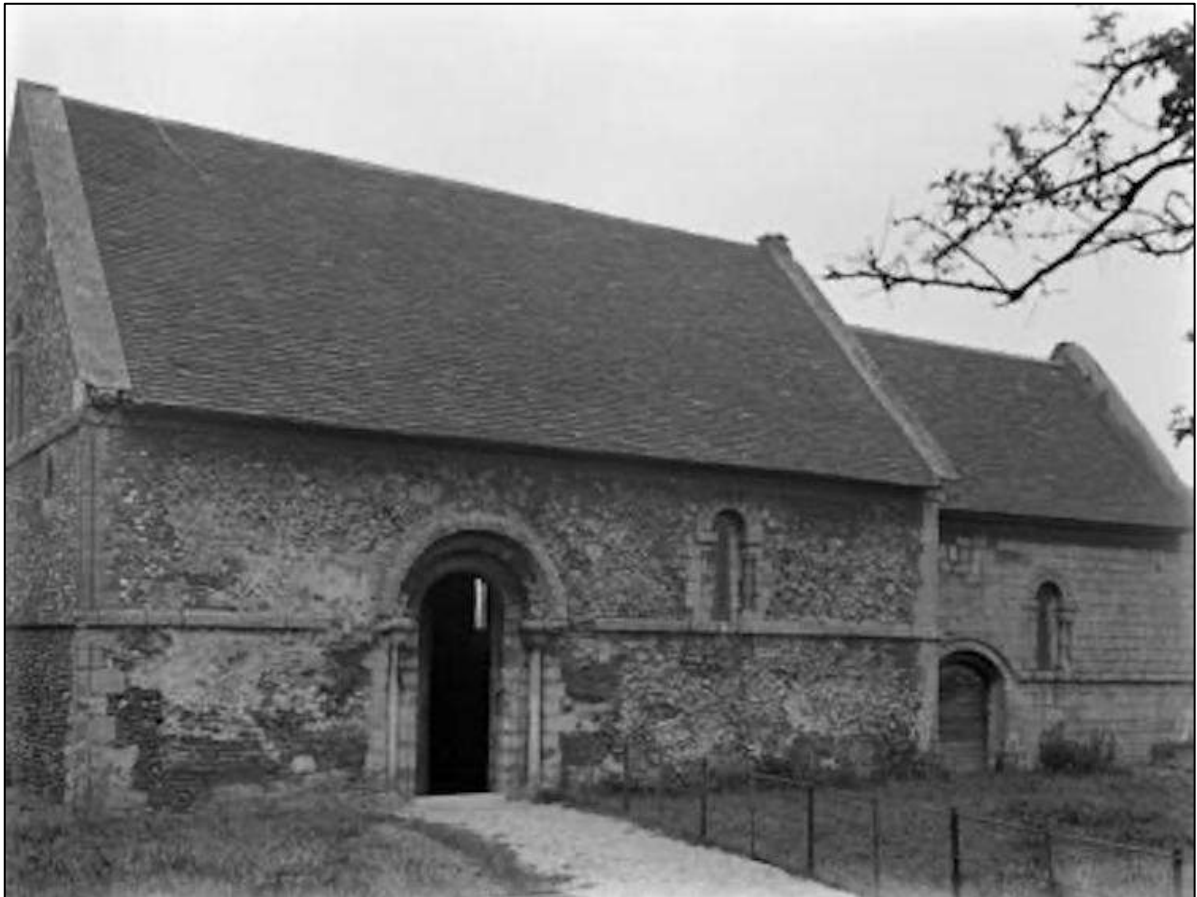
Figure 12: Photograph looking north showing the Cambridge Leper Chapel in June 1927. Note formalized path with handrail leading to the principal entrance of the building (Historic England Archive ref CC001431).

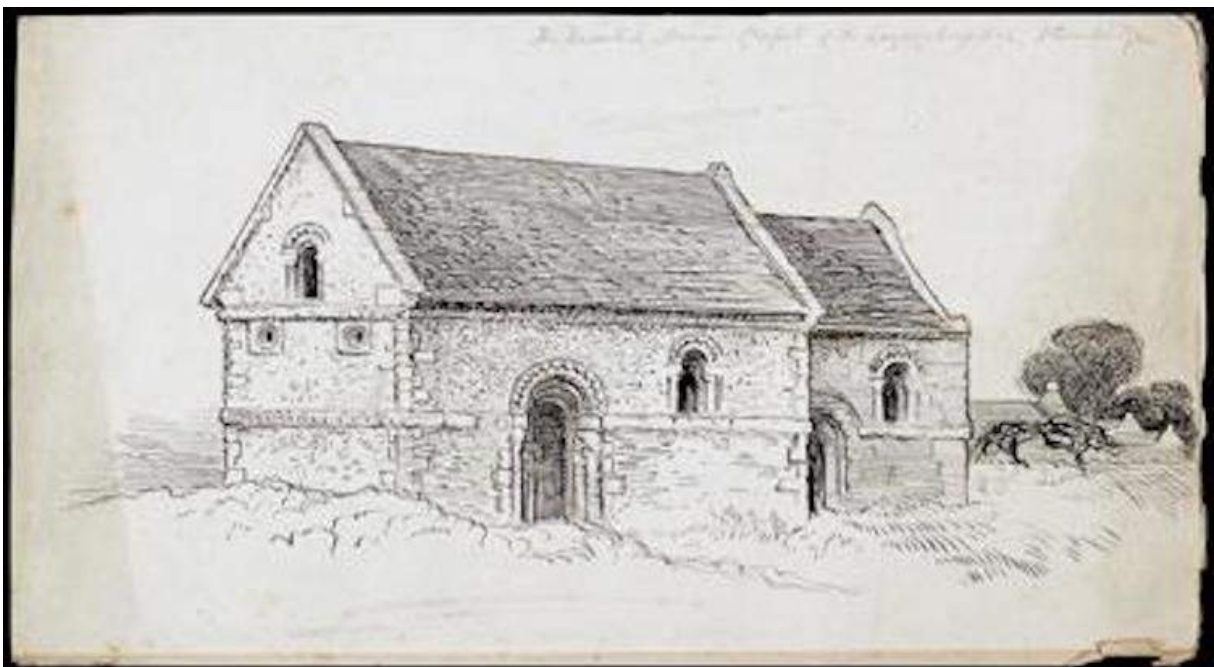
Figure 13: Drawing of the Cambridge Leper Chapel looking northeast, ca. 1892-1933 (Historic England Archive ref CGH01/01/0853).

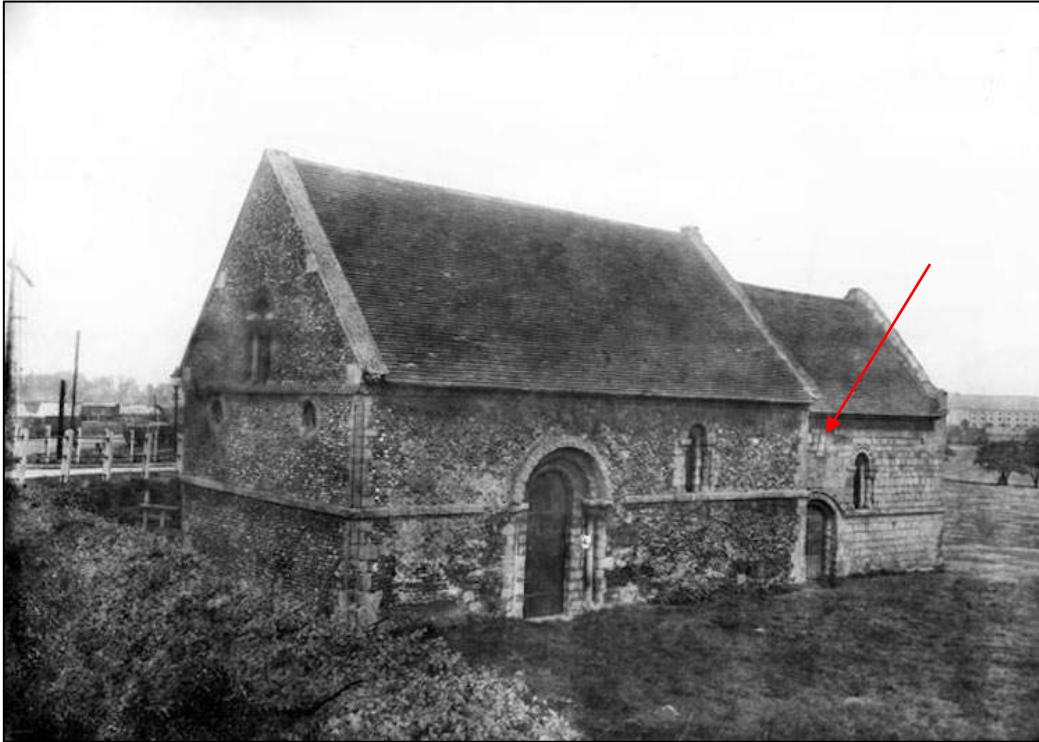
Figure 14: Photograph of the Cambridge Leper Chapel looking northeast, 1908. The photo was taken after installation of the Barnwell Junction station (left) in 1884 and before installation of the formal path leading to the front door in 1927. The red arrow shows the location of a former window with a noticeable repair (Historic England Archive ref: CC72/02035).

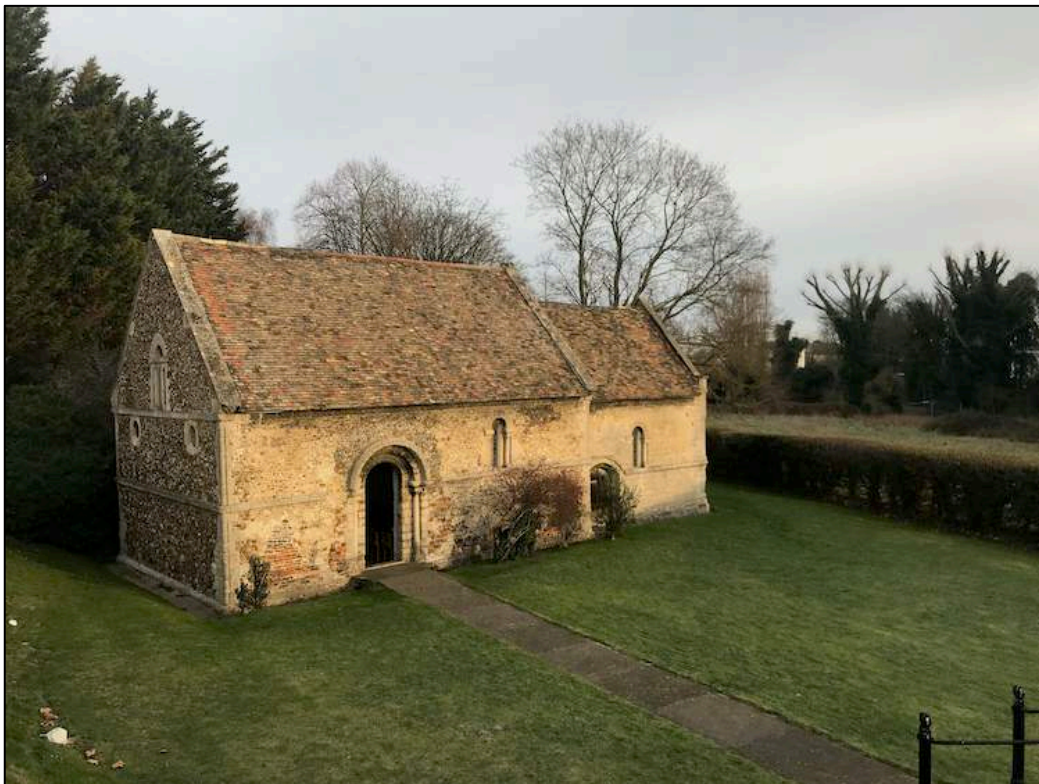
Figure 15: Photograph of the Cambridge Leper Chapel and its associated setting looking northeast toward the adjacent pasture that is separated from the building by a 20<sup>th</sup> century hawthorn hedge (Gjesfjeld 2019).

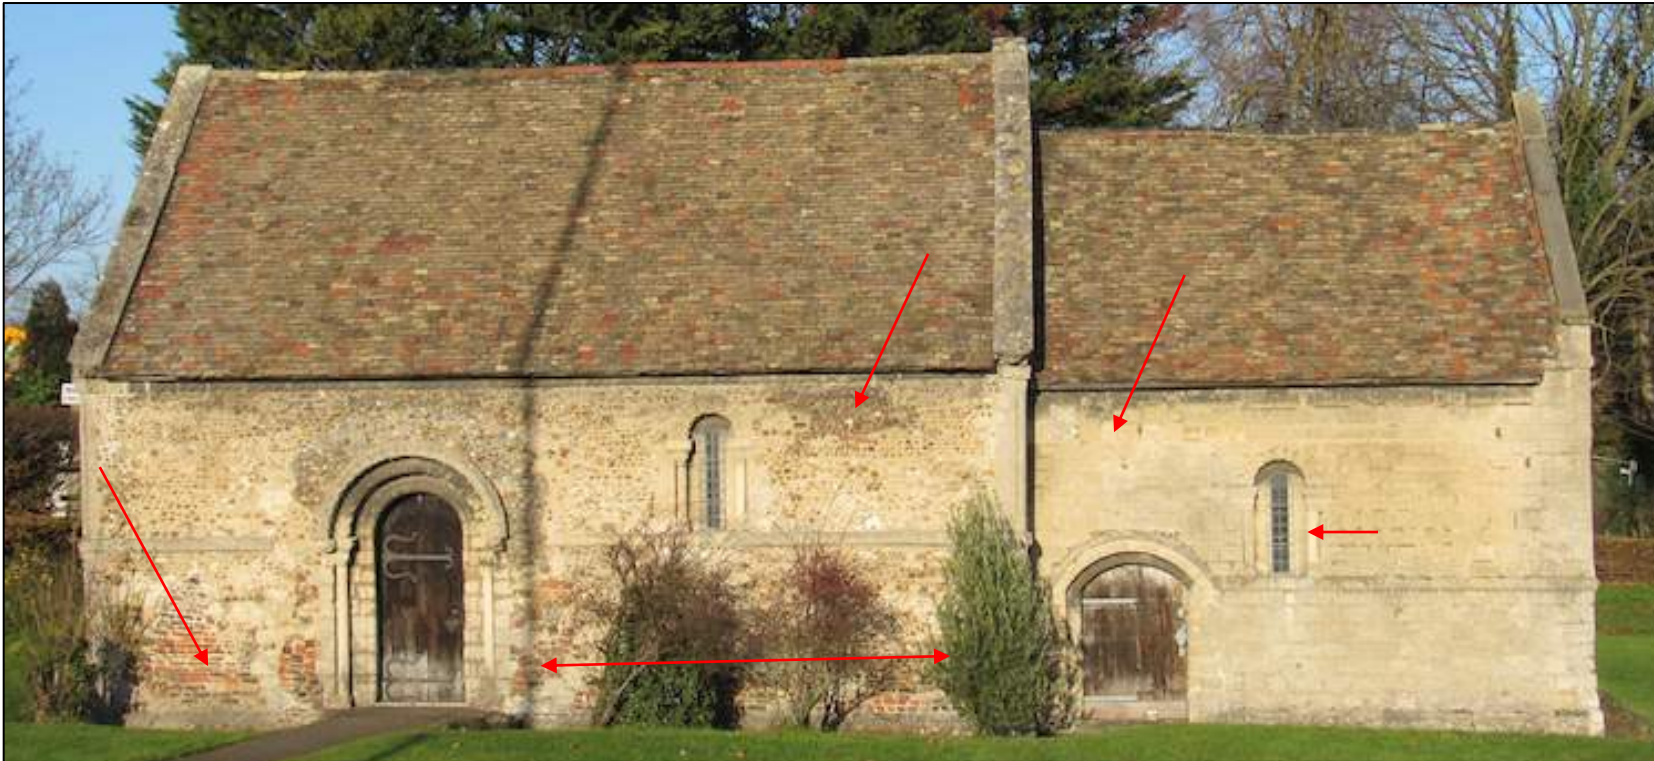
Figure 16: Photo of the Cambridge Leper Chapel looking northwest showing the nave (left) and the chancel (right). The red arrows at the far left and centre bottom shows a patchwork of materials including multiple shapes and sizes of bricks that were used to repair the nave under the string course. The two diagonal red arrows near the roofline show the approximate location of former windows noted in the 1725 drawing and Cotman's 1818 etching. The diagonal arrow in the nave illustrates a visible change in patina, while it is more difficult to see the former location of the window in the chancel. Generally, this side of the chancel shows the most refined finishing techniques, while change through time is more obvious on the other elevations. The arrow at the right in the chancel shows a replacement shaft near the window (Gjesfjeld 2019).

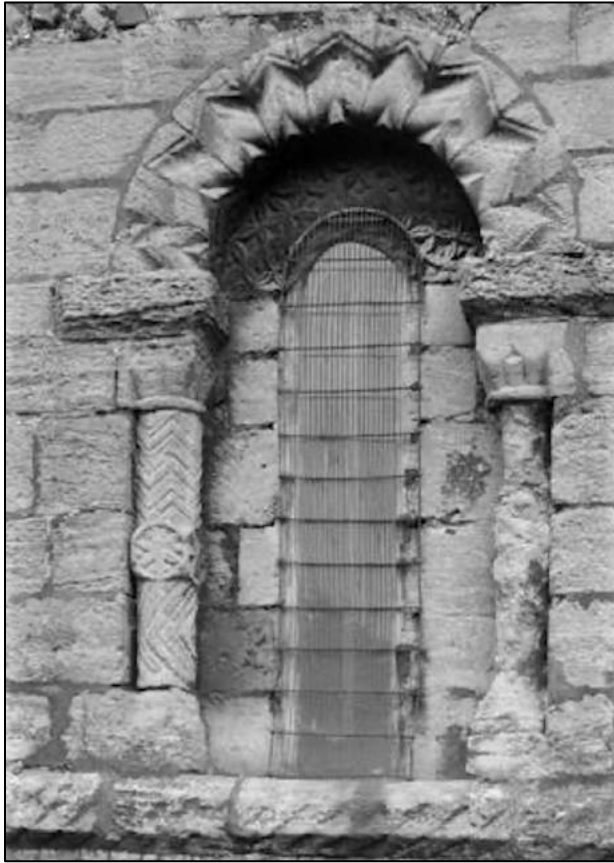
Figures 18 and 19: Historic photograph at the left shows the condition of the chancel window on the southern façade of the chapel on 25 May 1927 (Historic England Archive ref BB008139). The photograph at the right shows the condition of the window in 2019 with red arrow directed toward a 20<sup>th</sup> century replacement shaft (Gjesfjeld 2019).

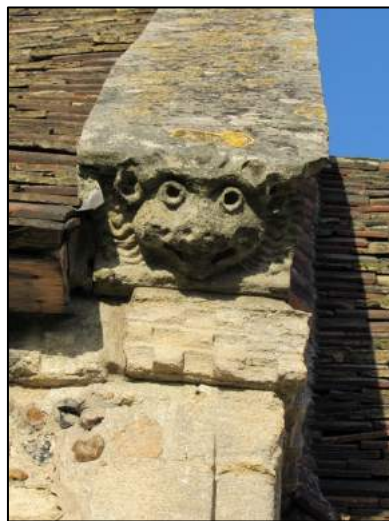
Figures 20 and 21: Photograph at the left illustrates detail of one of the grotesque figures on the nave. The bottom right photo shows the nave window on the south facade of the building. The red arrows show a repair to the left shaft as well as the introduction of a replacement shaft on the right (Gjesfjeld 2019).

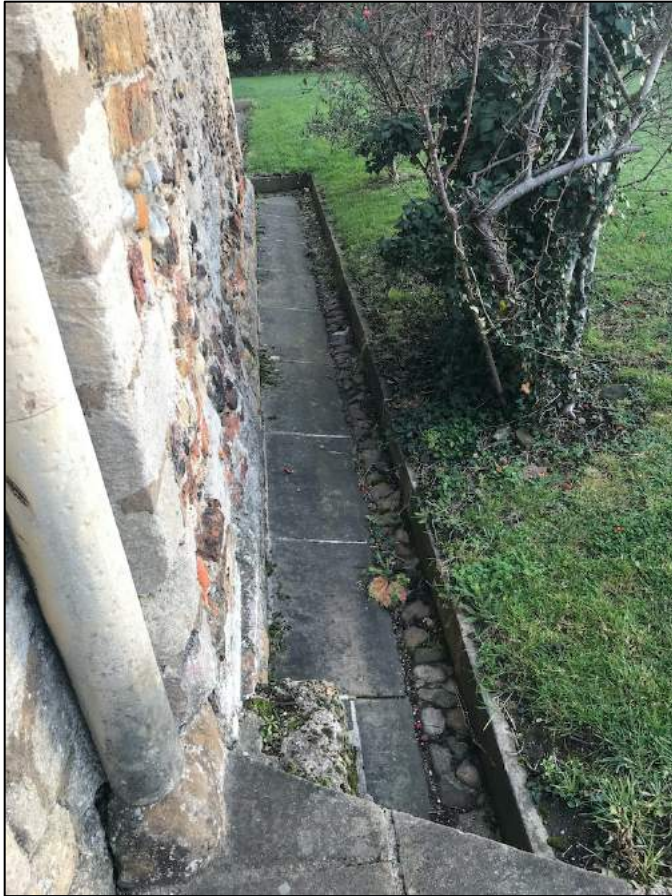
Figure 22: Photograph (above) looking east showing a drainage feature around the nave that was built to protect the building from dampness. The feature was installed at an unknown date, but further suggests modifications to the topography around the chapel (Gjesfjeld 2019).

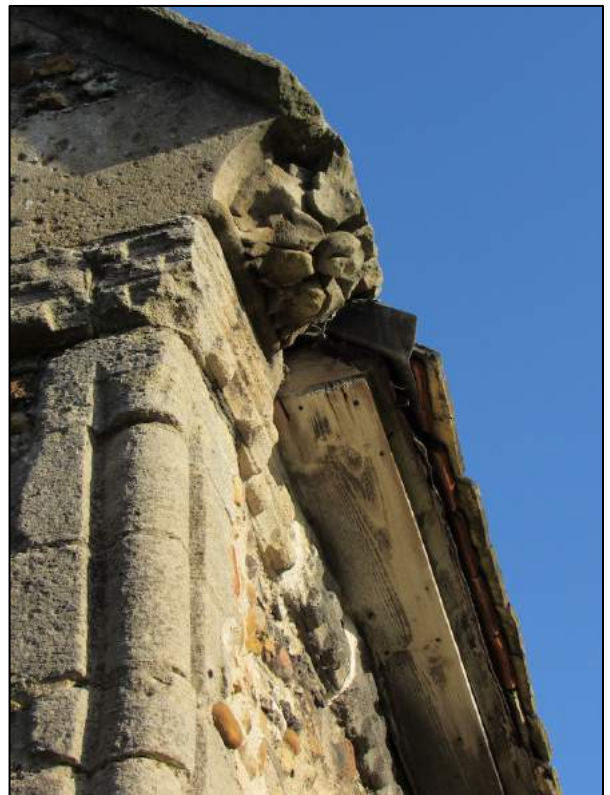
Figure 23: Photograph (right) showing interventions associated with the roof and soffit board under the drip edge of the nave. Also note floral motif at corner with billet string course and shafted stone quoins below (Gjesfjeld 2019).

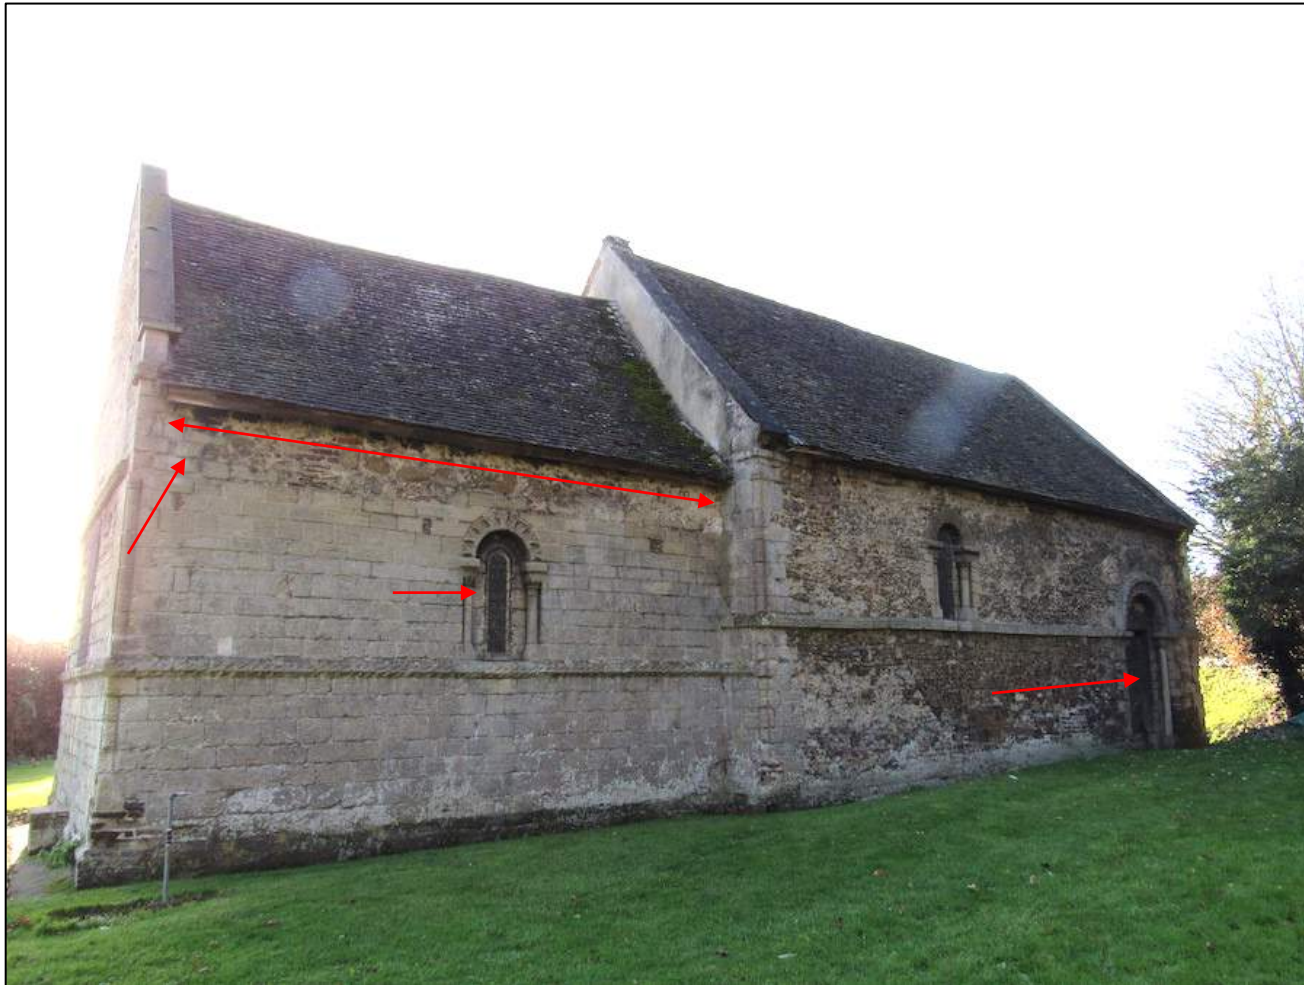
Figure 25: Photograph of the Cambridge Leper Chapel looking south. The red arrow at the top of the chancel shows a substantial repair and the introduction of new rubblestone and brick materials near the roofline. The red arrow at the far left in the chancel illustrates a 12<sup>th</sup> century worked stone that was salvaged and used in the rebuilding of the wall. The red arrow pointing to the chancel window shows work that was completed on the window in the 15<sup>th</sup> century. In the nave, the arrow at the right shows the door that has been bricked-in (Gjesfjeld 2019).

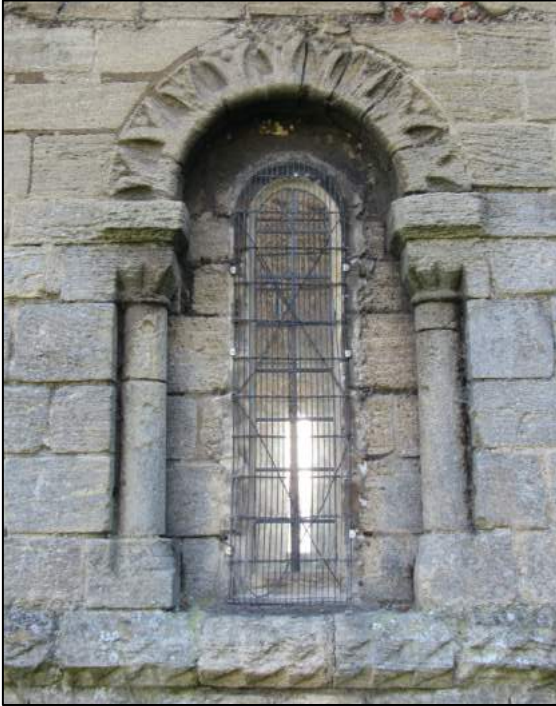
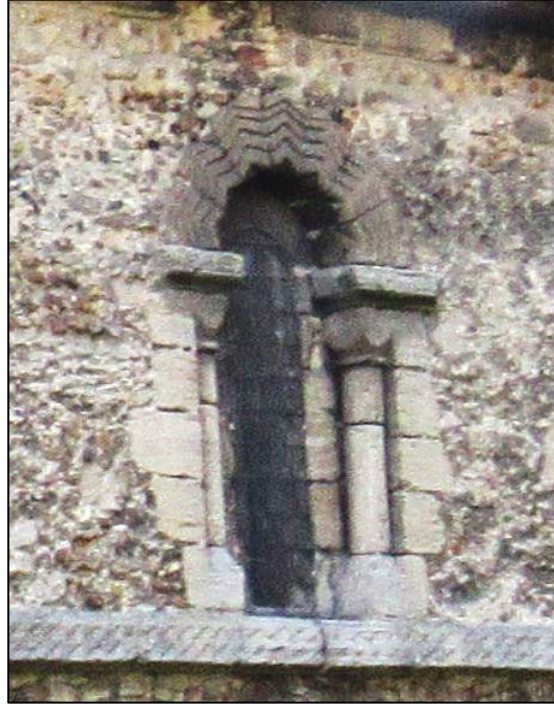
Figures 26 and 27: Photograph of the detail of the windows on the north elevation of the Cambridge Leper Chapel. Photograph at the left is the chancel window that was reportedly modified in the 15<sup>th</sup> century and the window at the right is in the nave. It is nearly identical to the window on the southern elevation of the nave (Gjesfjeld 2019).

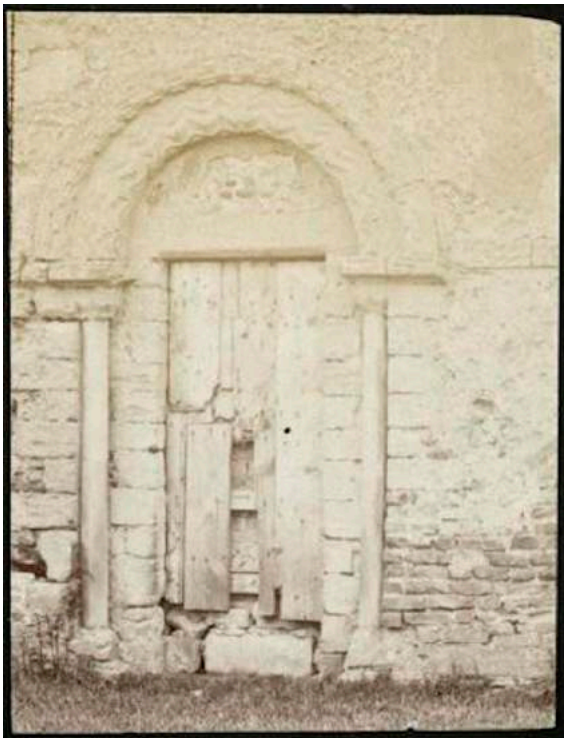
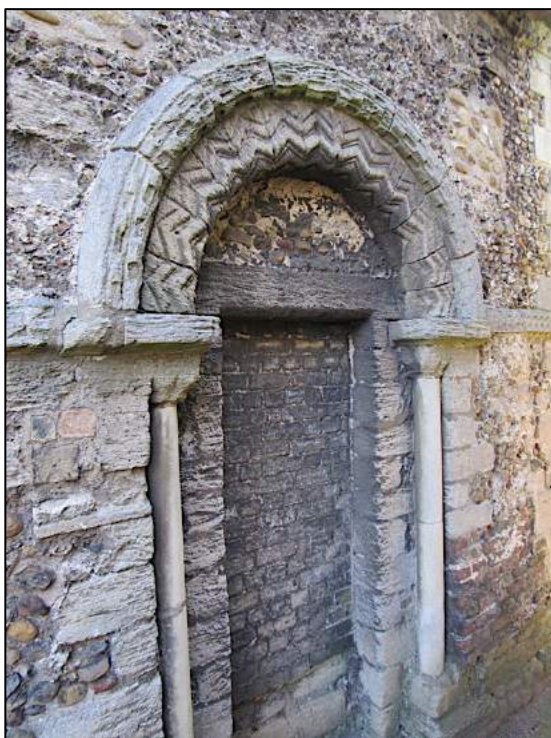
Figures 28 and 29: Historic photograph at left showing deteriorated condition of the door on the northern elevation of the chapel ca. 1875-1895 (Historic England Archive ref RBO01/05/OP22307). Photograph at the right shows the contemporary condition of the bricked-in door and its associated lintel and decorative features (Gjesfjeld 2019).

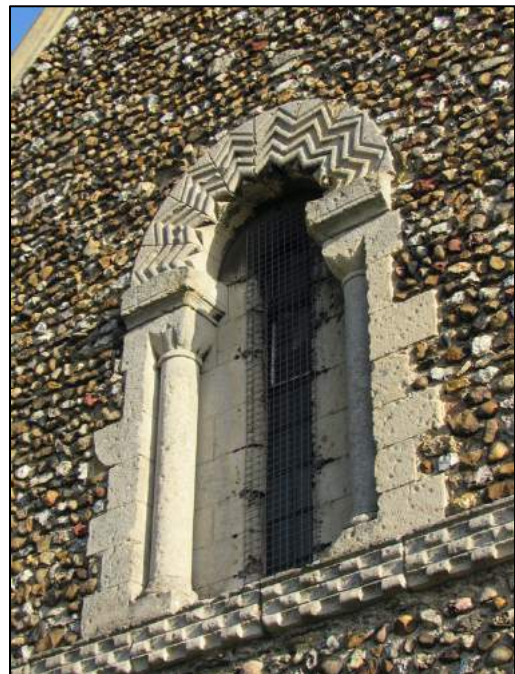
Figure 31: Photograph showing the detail of the window on the western elevation of the chapel. Stylistically, the window is the same as windows found on the nave; however, the crisp, clean lines associated with the carved Weldon stone serve as an indicator that the window was installed during the 19<sup>th</sup> century rebuilding of the west wall by Gilbert (Gjesfjeld 2019).

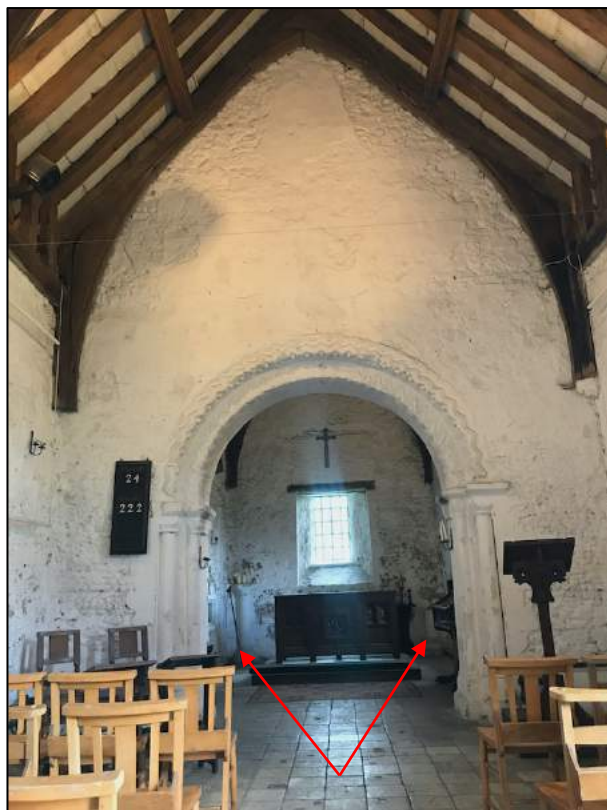
Figures 32, 33 and 34: Etching at the top left of the page shows the interior of the Cambridge Leper Chapel in 1818. Note the lack of a window opening in the chancel as well as the general state of disarray in the interior (Cotman 1819). Photograph of the interior of the chapel at centre right shows interior arrangement and the addition of a window in the chancel (RCHM 1959). The contemporary photograph at the bottom left shows many of the same furnishings that were present in 1959, including the harmonium, which was relocated to the chancel. The red arrows show two vault supports that were associated with the original vaulted ceiling. The principal rafters, wall plate, and posts of the timber roof are also visible (Gjesfjeld 2019).

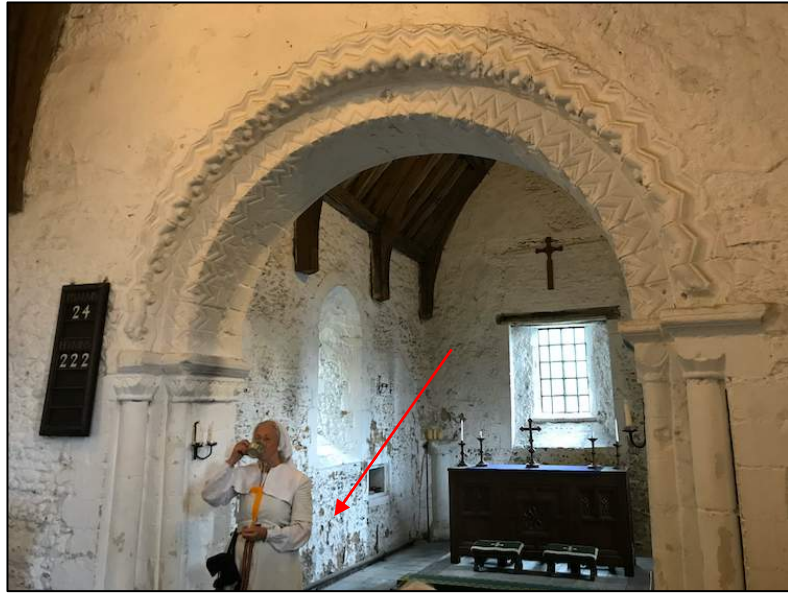
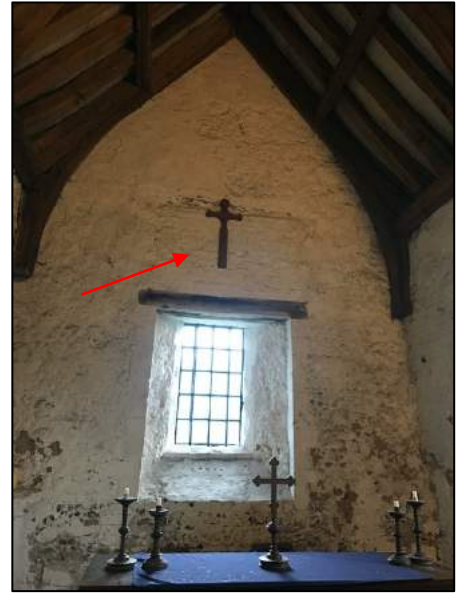
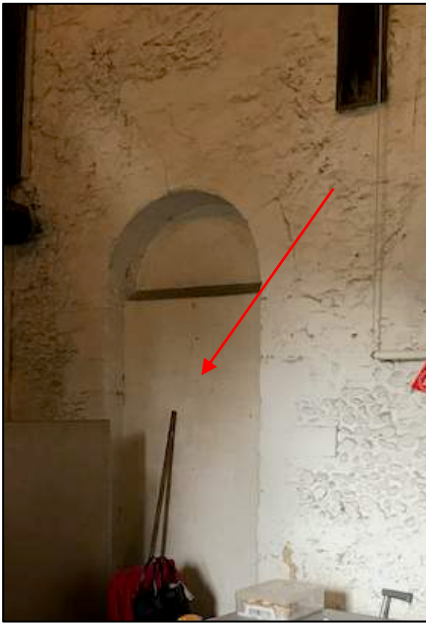
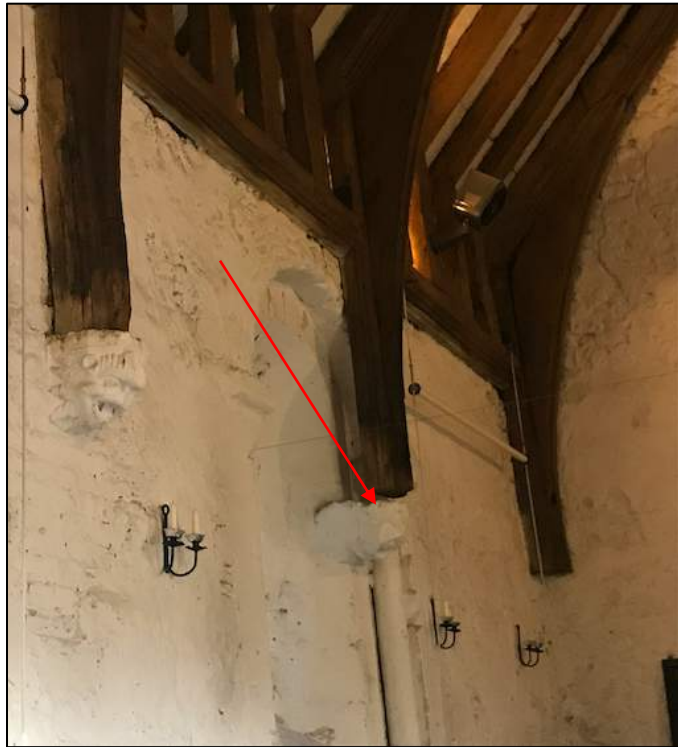
Figures 35, 36, 37 and 38: Photograph at the top left shows the interior of the Cambridge Leper Chapel and detail of the chancel arch. The red arrow points to the north wall of the chancel where there is evidence of fabric decay due to the application of masonry paint on the walls, which has trapped moisture (Gjesfjeld 2019). The red arrow in the photograph at top right shows 19<sup>th</sup> century modifications made to the window opening in the chancel (Gjesfjeld 2019). The photograph at the bottom left shows the door on the northern wall of the nave that is blocked (Gjesfjeld 2019). The photograph on the bottom right shows the wall plate and associated timber posts in the nave. The posts conflict with the arched window openings and there is a gap between the corbel and the bottom of the post (Gjesfjeld 2019).

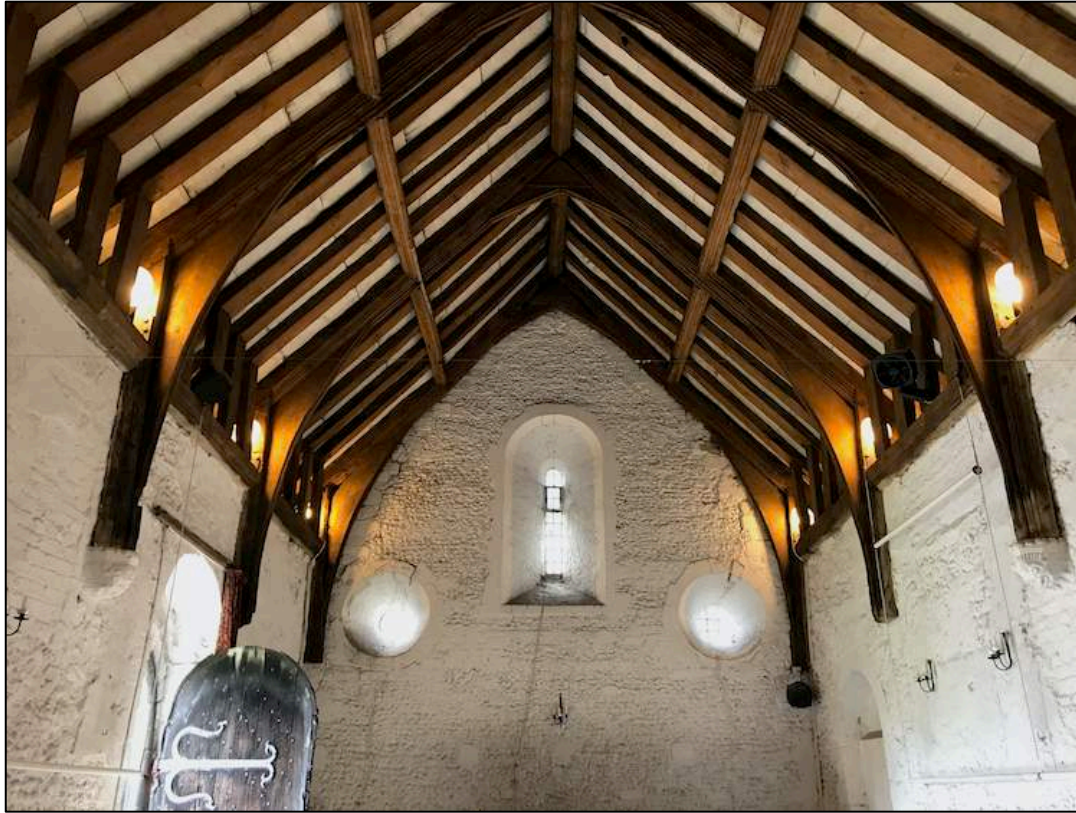
Figure 39: Photograph of the interior of the Cambridge Leper Chapel (above) looking toward the west wall that was reconstructed by Gilbert. This photograph illustrates the importance of the splayed window, which was designed to let more light into the chapel through the small windows (Gjesfjeld 2019).

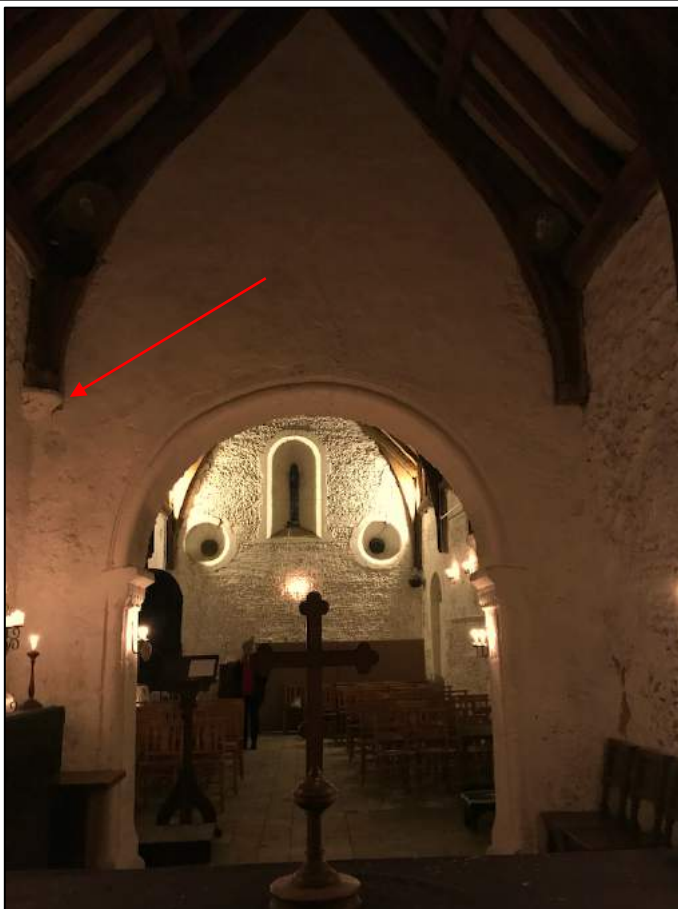
Figure 40: Photograph by candlelight looking west from the altar showing the relatively simple design of the chancel arch from this perspective. Also note roof with curved braces and remaining half-angel corbel identified by the red arrow (Gjesfjeld 2019).
